# PROJECT SAFETY ALERT

No- 013

## Hose Coupling Failure

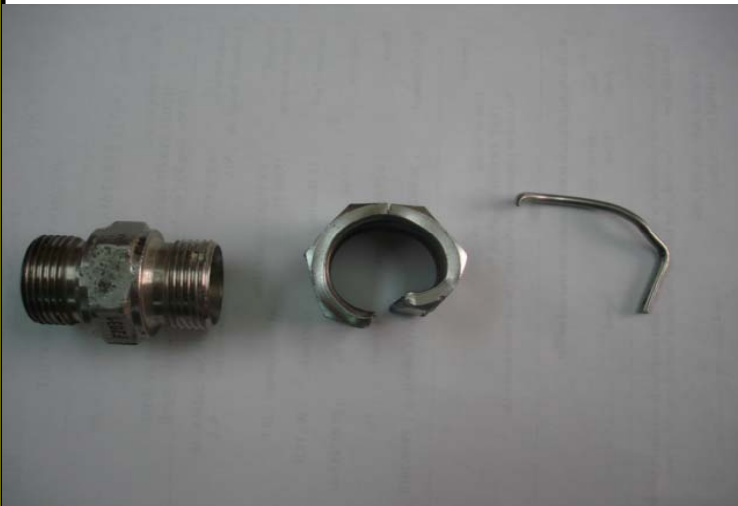
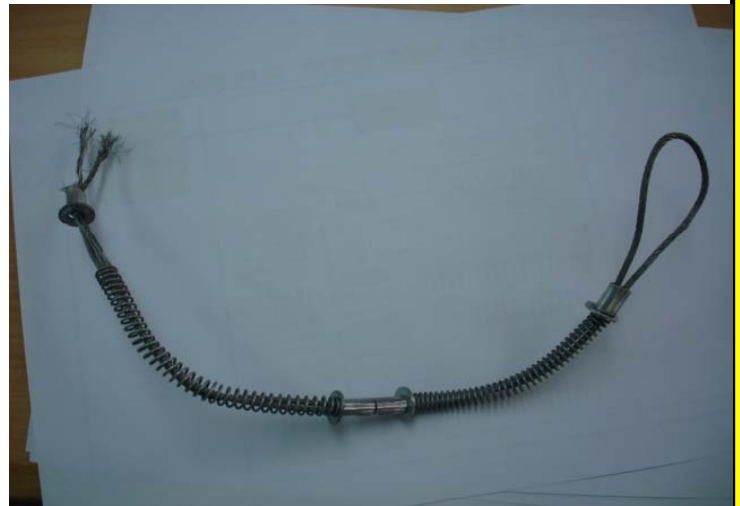
On 17th October 2009 around 15:00 hours, during the hydro milling preparation work for Train 7 N2 compressor lube oil interconnecting line @ south side of Train 7 N2 L/O skid, the high pressure hose coupling connection failed and broke off. The safety hose whip check installed between the connections also failed and the hose whipped and struck one of the operators across both legs thigh height causing abrasion & bruising, who was standing approx 1.5 - 2m away from the connection at.

- During pressurization of hydro test, pneumatic test, hydro milling, etc all personnel must stand at a safe distance from connection points in case of failure.
- All safety whip checks to be pre- inspected prior to installation to ensure they are functioning correctly and no visual defects are present.
- All pressure testing must be controlled by the responsible testing group ensuring sufficient barricaded area for the test and appropriate signage & warning tape displayed to keep non essential personnel out.
